CiDRA CYCLONetracSM at Kennecott Utah Copper

Dylan Cirulis (Kennecott Utah Copper), Jerin Russell (CiDRA Minerals Processing)

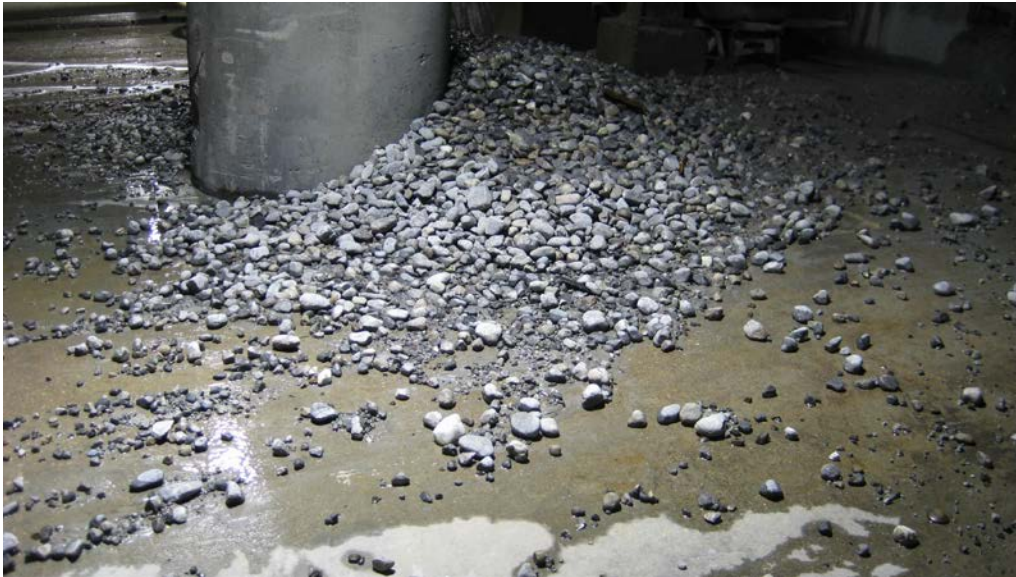
Figure 2 – Rock flushed from a rougher row after a significant rock event

The target grind size for flotation feed at Copperton is 32% +150micron (100 mesh). Hydrocyclone product greater than 150micron is considered coarse or oversize. Particles 6mm (~1/4") or greater can be considered "rocks" and a large flow of this material can block the internals of the flotation cells, significantly impacting their performance. *Figure 2* shows an example of the material that is flushed from a rougher row after a severe rock event. Some causes of "rock" events include:

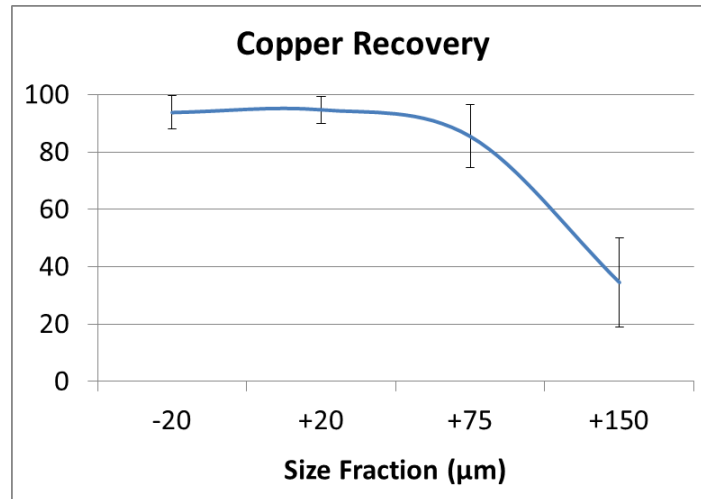
Figure 3 - Copper recovery by size fraction

Recovery of liberated and middling +150micron mineral particles in the flotation circuit is significantly lower than -150micron particles. Based on mineral liberation analyzer (MLA) data, the long term average +150micron copper recovery is significantly lower compared with recovery of -150 micron particles (see *Figure 3*). It is also worth noting that the recovery of +150micron size fraction is considerably more variable than for the -150micron size fraction.

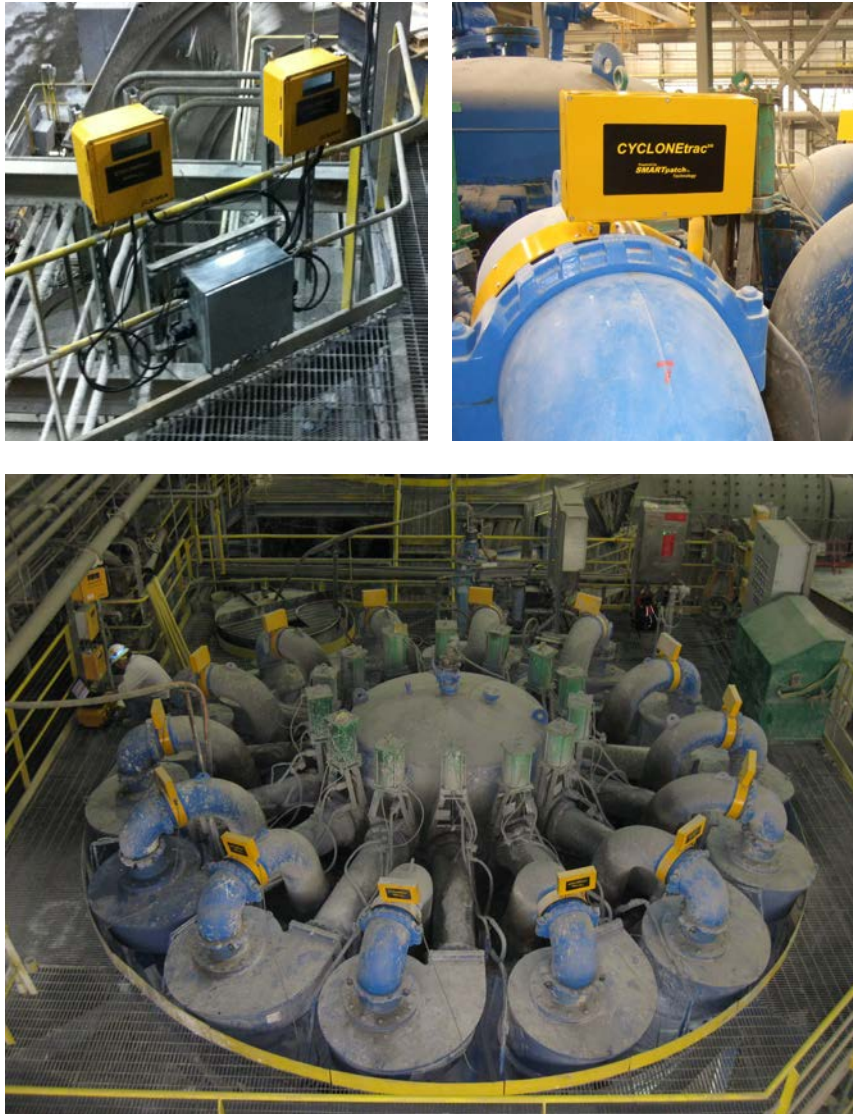
Figure 4 – CYCLONEtrac installed on hydrocyclone battery 8

The prototype hardware was first installed on a hydrocyclone battery at Copperton to record real-time acoustic data directly to a mass storage device. The data was post processed and used to develop the initial CYCLONEtrac algorithms. Then the CYCLONEtrac system performance was compared to Copperton's existing oversize material detector installed in the combined overflow of the battery. The CYCLONEtrac detection algorithm was refined and the hardware and software designs were validated. A full system was then built and installed on all 8 hydrocyclone batteries in the grind plant. *Figure 4* shows the transmitters and junction box for one battery, the CYCLONEtrac band installed on an overflow pipe, and a full battery instrumented with CYCLONEtrac bands.

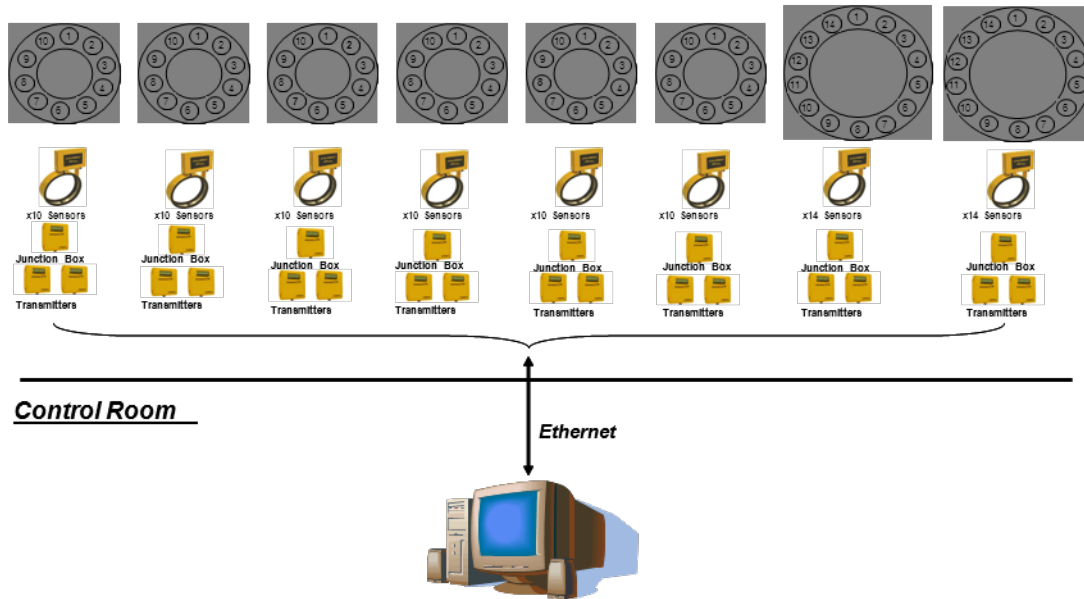
Figure 5 - CYCLONEtrac system diagram

The system consists of a sensor and preamplifier attached to the external pipe surface on the overflow of each hydrocyclone. A schematic of the system is shown in *Figure 5*. The preamplifier outputs are connected to transmitters which perform the first level data processing for each battery. The data accumulated by the transmitters is aggregated by

a computer in the Copperton control room. This data is used by the CYCLONEtrac system to determine the operational state of each individual hydrocyclone and of each battery of hydrocyclones. In addition to the real-time display, data is stored for local review and transmitted to the CiDRA data center for the generation of daily and weekly performance and utilization reports. Both the displayed data and the summary reports facilitate smart maintenance scheduling and aid in troubleshooting to reduce the downtime associated with periodic maintenance and repairs.

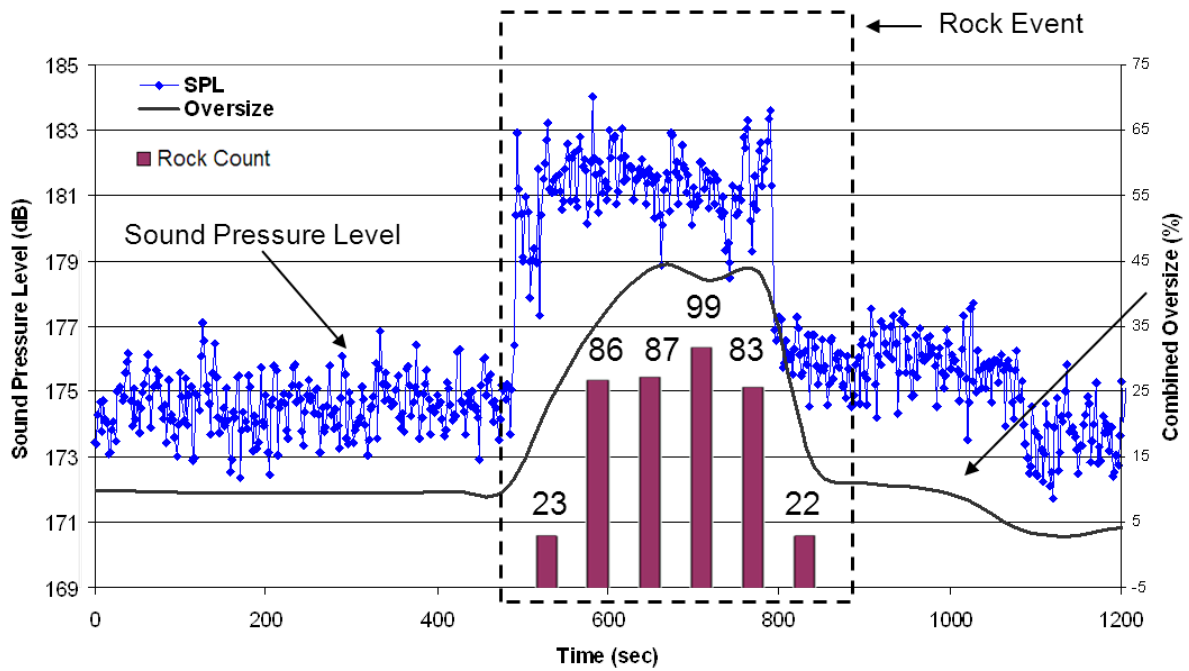
Figure 6 - 2/3/2009 rock event data

Using the defined system threshold parameters the system successfully detects a sustained rock event. This data was then compared to Copperton's oversized particle detection system data from the data historian. The CYCLONEtrac system detected this event as displayed in *Figure 6*. The blue trace is the CYCLONETRAC sound pressure level (SPL) calculated by CYCLONEtrac. The blue trace shows that the SPL of the acoustic signal for hydrocyclone #3 increases more than 6 dB during the event. The overlaid maroon bars represent the number of impacts detected by CYCLONEtrac for each minute of the event (from rocks striking the inner pipe wall), as defined by the algorithm.

The event terminated rapidly (at 800 seconds on the plot) when feed flow stopped to the effected hydrocyclone by closing the isolation valve. The SPL dropped very quickly while the number of rocks and the oversize detector signal roll off more slowly due to slower sample rates.

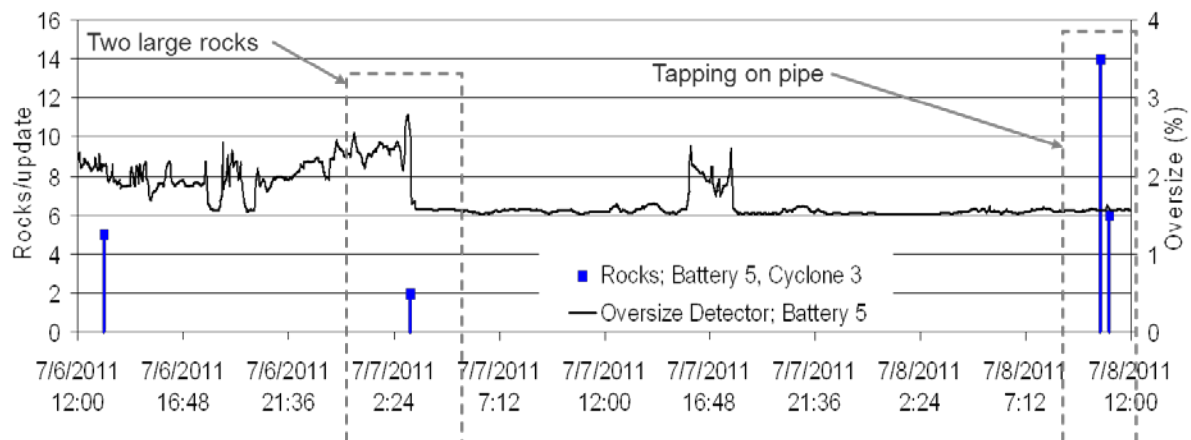
Figure 8 - Sample basket test data

A short sampling campaign completed in July of 2011 was designed to further confirm the performance of the system. A sample basket assembly was attached to the overflow discharge of two hydrocyclones on separate batteries for 24 hours and 48 hours respectively. During these two sampling periods, the CYCLONEtrac system was utilized to determine the number impacts on the pipe wall, indicating that rocks were reporting to the overflow of the particular hydrocyclone under test. At the conclusion of the sampling period, the material collected in the basket was removed, dried and analyzed. There was a correlation between the number of rocks (wall impacts) detected and the number of rocks collected. Of interest is that at the point where the rocks were detected, the combined overflow % oversize detector signal also spiked.

The number of rocks large enough to be detected was small, so it is only an assumption that the rocks collected were those causing the impacts. The highlighted region on the left side of *Figure 8* shows the corresponding rise in the output of Copperton's oversize particle detector, at about 2:24 on 7/7/2011, and the two wall impacts that were detected by CYCLONEtrac at the same time (assumed to be the two large rocks that were recovered from the sample basket).
